# Lampasas River Watershed Partnership

Steering Committee Meeting  
November 18, 2010

Lisa Prcin  
Watershed Coordinator  
Texas AgriLife Research at  
Blackland Research & Extension Center

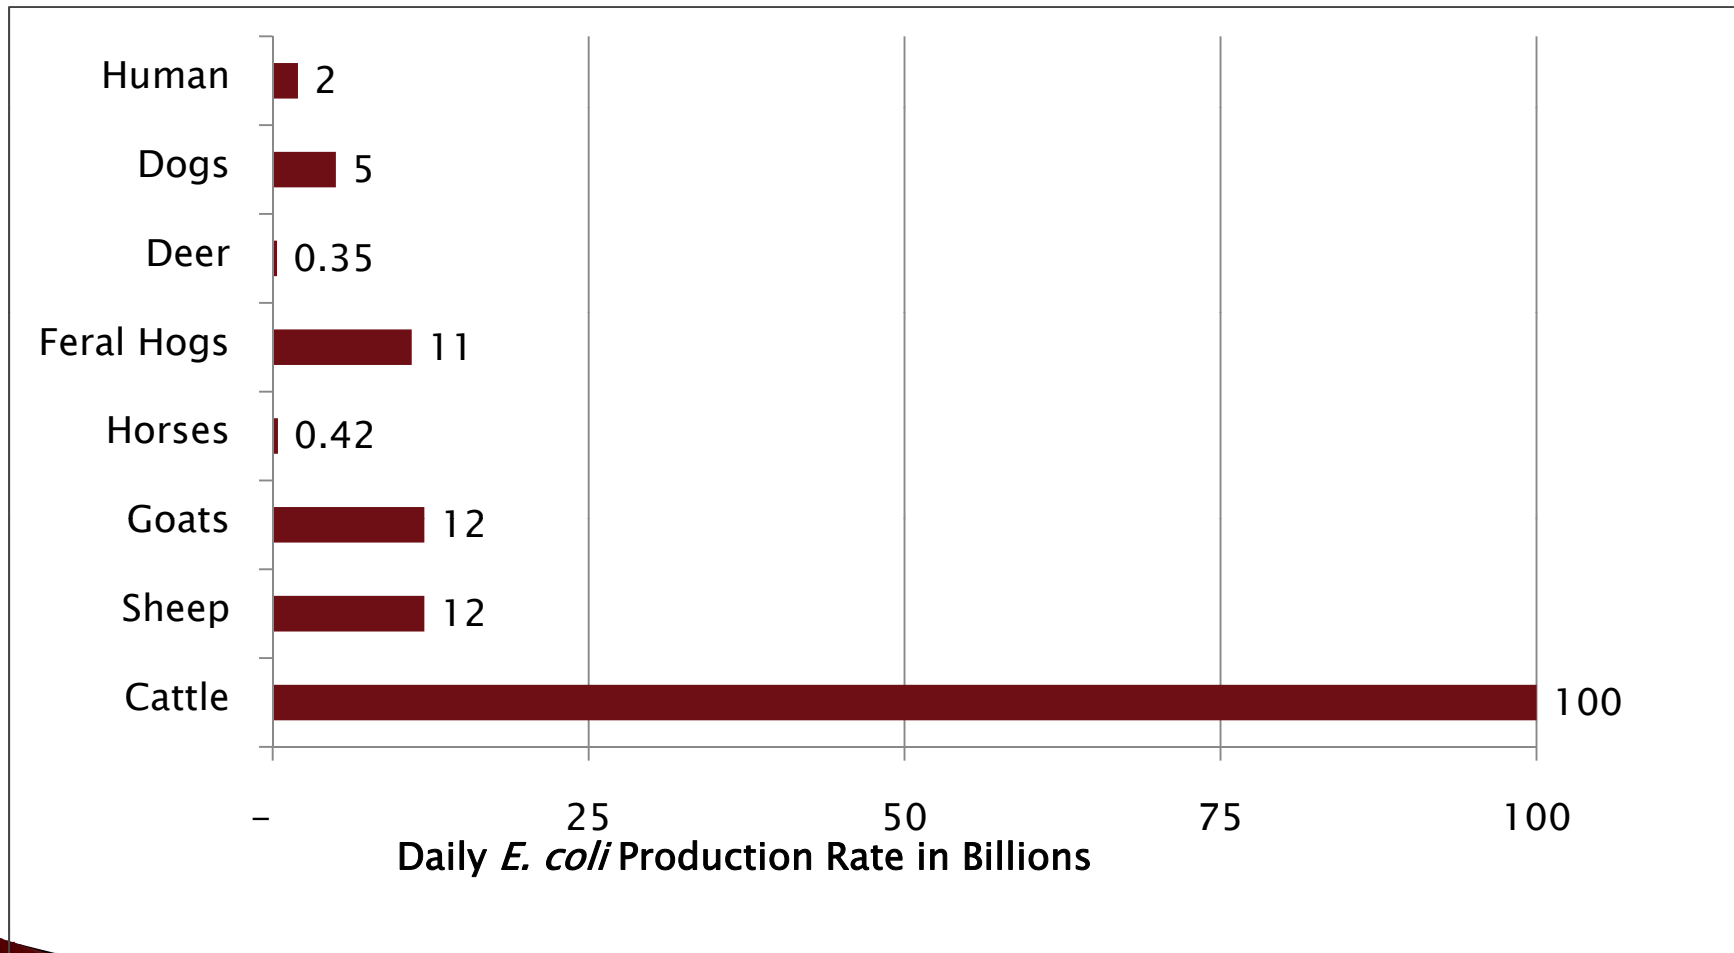
# Daily *E. coli* Production Rate by Source (in billions)

Excerpt from USEPA, 2001. Protocol for Developing Pathogen TMDLs: Source Assessment. 1<sup>st</sup> ed. EPA841-R-00-002. Ch 5 pp 1-18. Washington, D.C.:USEPA Office of Water

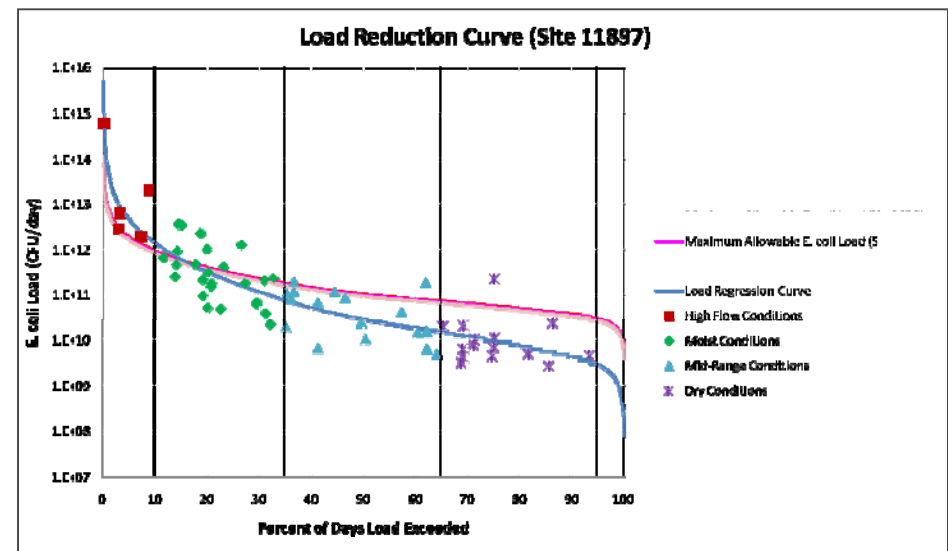
- ▶ Developed Load Duration Curves for six water quality sites in watershed
  - Percentage of time a pollutant load meets or exceeds a target level
- ▶ Water quality analysis indicates no need for bacteria load reduction, with the exception of during the High Flow Regime
